Essa Township 5th Line Bridge Rehabilitation

Schedule 'C' Municipal Class Environmental Assessment
Public Information Centre No. 1

November 29, 2021

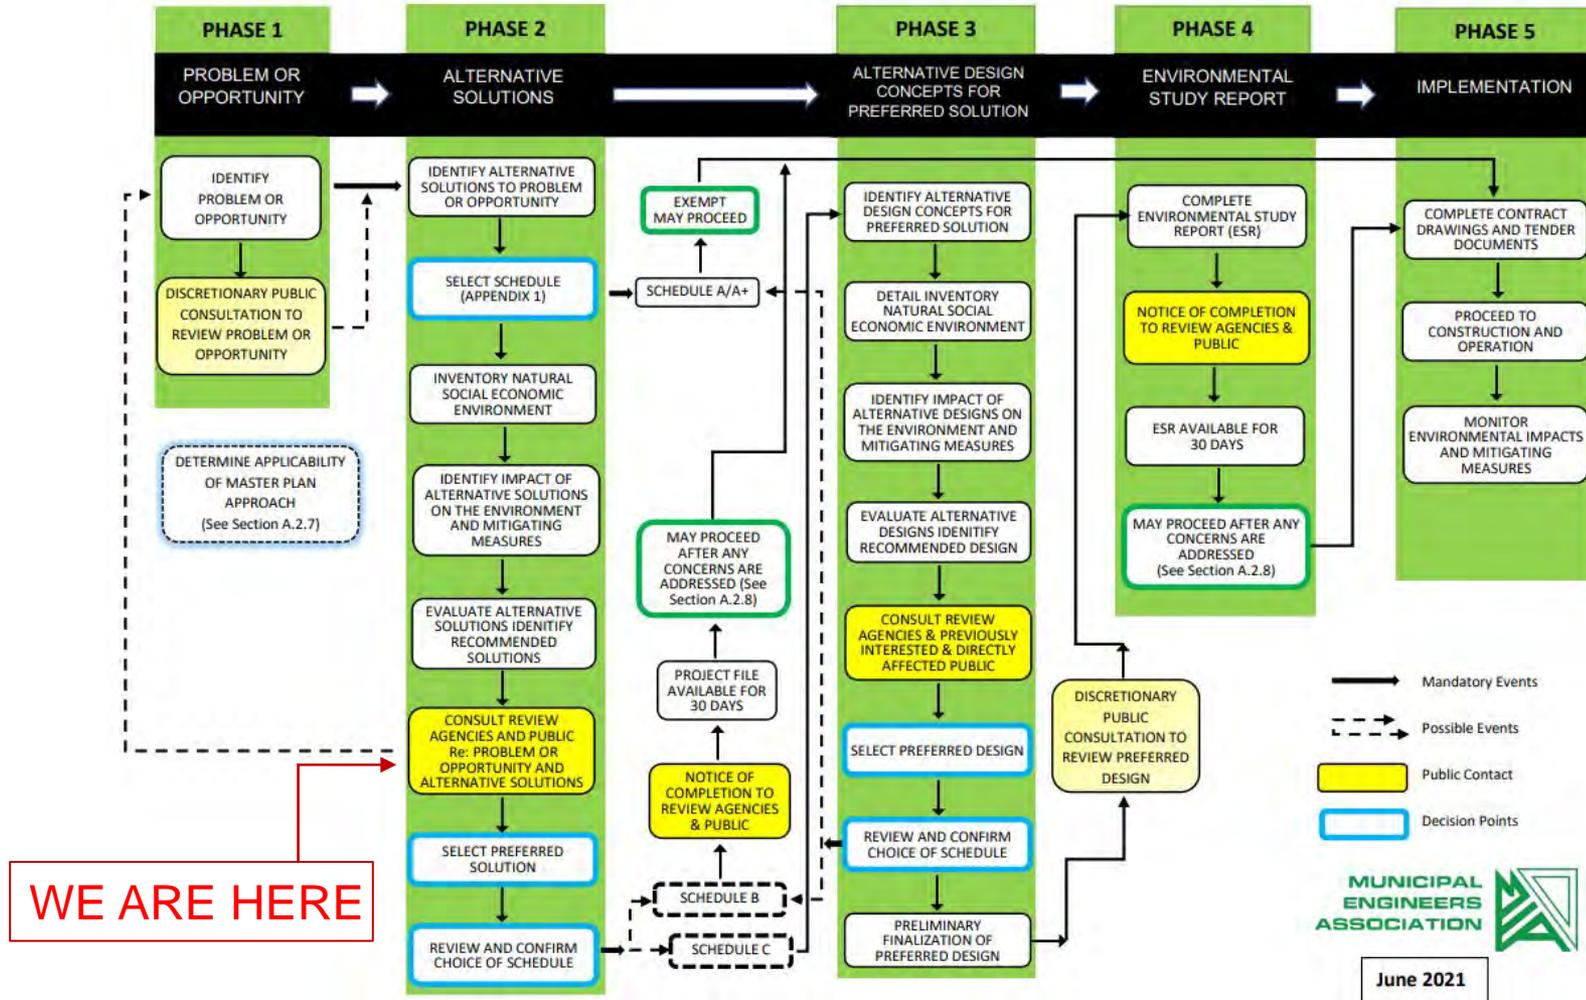
Municipal Class EA Process

- This project is classified as a Schedule ‘C’ in accordance with the Municipal Class Environmental Assessment (Oct. 2000, as amended 2007, 2011 & 2015) and requires completion of Phases 1 to 4 of the process.

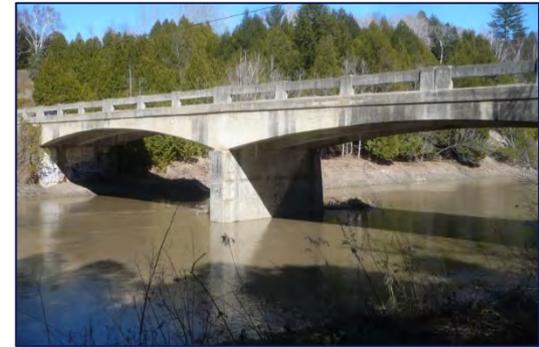
Bridge No. 9 West Elevation View (2019)

- The existing Bridge No. 9 is a two-span continuous concrete T-beam bridge with a concrete deck and a concrete wearing surface.
- The deck is supported on three concrete beams cast integral with the deck. The beams are supported on concrete abutments and a central pier constructed normal to the road alignment.
- The structure is 52m long, with only a 6.1m wide platform between barriers. As a result, it currently operates as a single-lane structure, rendering it functionally deficient for the volume of traffic it services.
- The southbound roadway approach is quite steep and on a curve, so the sightlines do not meet the standard requirements for the posted speed limit.

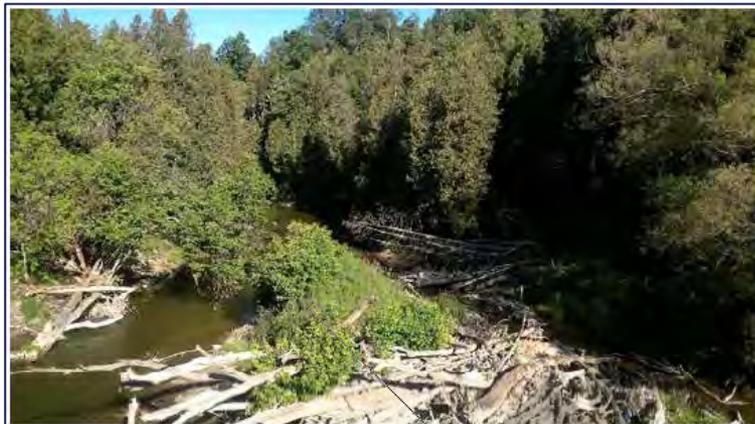
Downstream of Bridge, June 2021 Riverstone Environmental

- Natural Environment (continued)
 - The pier slows the velocity of the water on the downstream side of the pier creating an area of deposition. This deposition has continued to accumulate over time creating a sizeable formation in the river, as the island extends for more than 55 m downstream from the bridge pier.
 - The quantity of woody debris in the channel leads to the conclusion that the river is actively eroding the riverbanks. Erosion is occurring at the toe of this slope, particularly on the downstream side of the river. On the other side of the road an exposed, unvegetated slope is also a concern. The other location is just downstream of the bridge where the slope has partially failed already.
 - Logjams are common at this location and are an erosion concern while also increasing the potential for upstream flooding.

River System and Bank Stability	Red	Orange	Green	Green	The existing bridge pier is causing the formation of the island, major logjams, and erosion along the upstream and downstream banks. Option 2 would not remove the central pier, however some bank protection measures could be explored. Option 3 and 4 design structure would eliminate the central pier and could include bank protection adjacent to the existing abutments to prevent scouring in the future.
Surface Water	White	Orange	Orange	Red	Options 2 and 3 may result in temporary construction disturbance to a small drainage feature conveying runoff. Option 4 would likely require re-alignment of this feature within the ROW. Removal of tree cover would result in decreased shading, and potentially increase water temperature prior to the feature entering the main river channel.

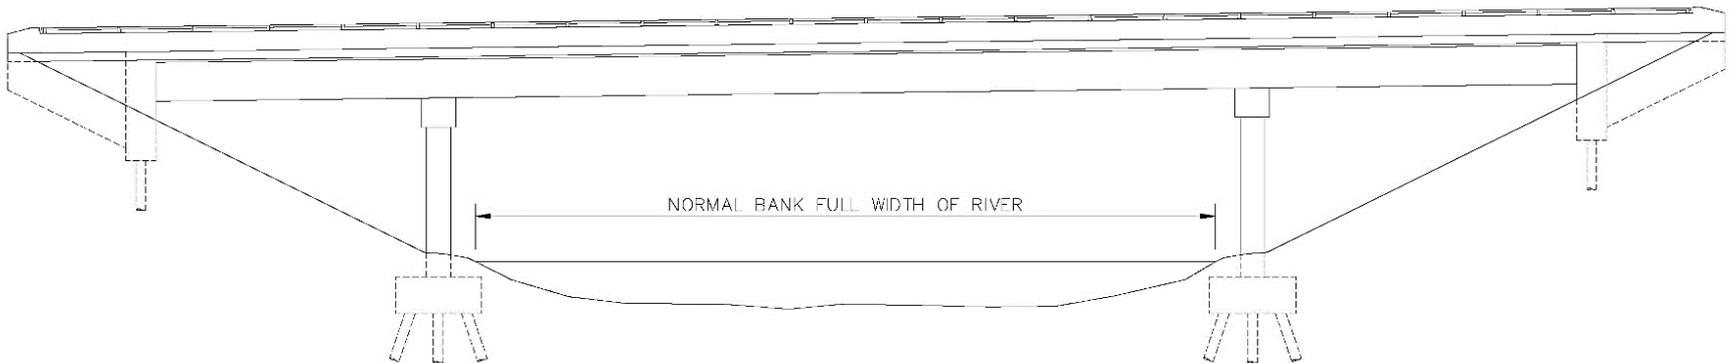
This option involves replacing the bridge structure in its existing location. The new bridge would be of sufficient width to support two lanes of traffic and would meet all requirements of Transportation Association of Canada (TAC) Geometric Design Guide for Canadian Roads, Canadian Highway Bridge Design Code (CHBDC) and RDM. The replacement would provide an opportunity to adjust the road profile and bridge elevation to improve the overall vertical alignment. The central pier would be eliminated and the new bridge would be three spans with piers set outside the bankful width. Erosion protection measures along the banks would also be reviewed along with removal of sediment deposition from the river to restore channel flow. In addition, slope flattening and vegetation removal would be considered to improve sightlines. (Drawing for illustration purposes only)

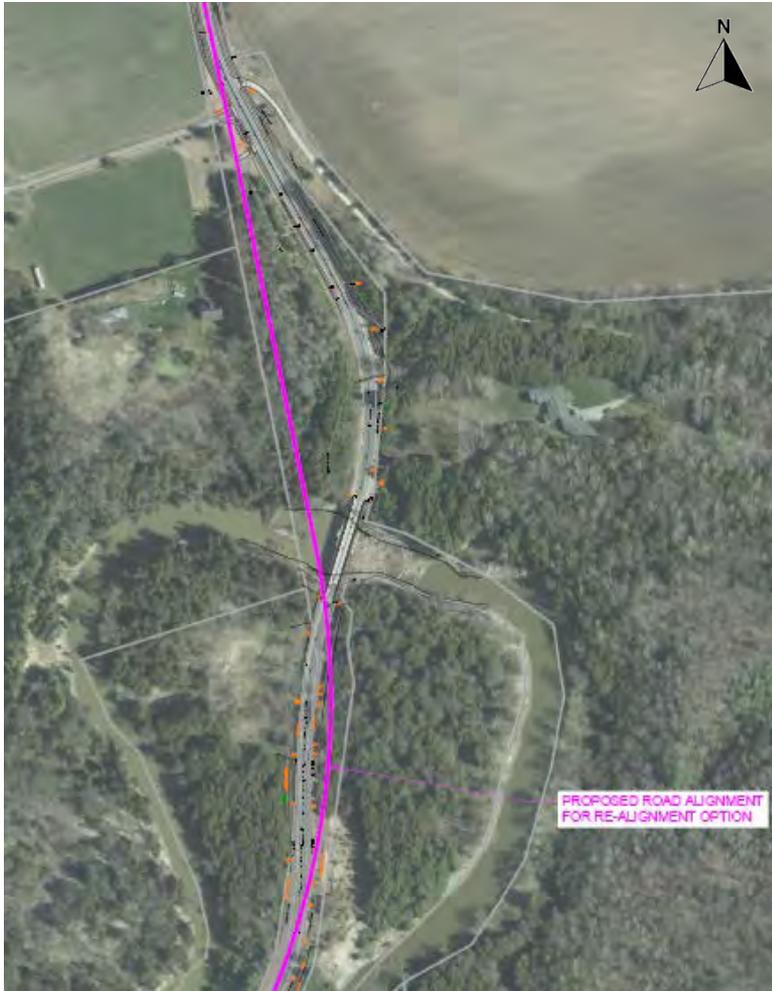
- ***Option 4 - Replace Bridge on New Road Alignment to the West***
 - The existing bridge structure would be demolished and a new bridge constructed west of the existing location, remaining within the ROW. The new bridge would be of sufficient width to support two lanes of traffic and would meet all requirements of Transportation Association of Canada (TAC) Geometric Design Guide for Canadian Roads, Canadian Highway Bridge Design Code (CHBDC) and RDM. As part of this option the road alignment on the 5th Line approaching the bridge from both directions (north and south) would be adjusted to 'straighten' the curves in the road.
 - Erosion protection measures along the banks would also be reviewed along with removal of sediment deposition from the river to restore channel flow.
